REMOVAL ACTION CONSTRUCTION COMPLETION REPORT

TREATMENT OF IMPACTED SOILS

GRANVILLE SOLVENTS SITE

June 25 – August 30, 2001

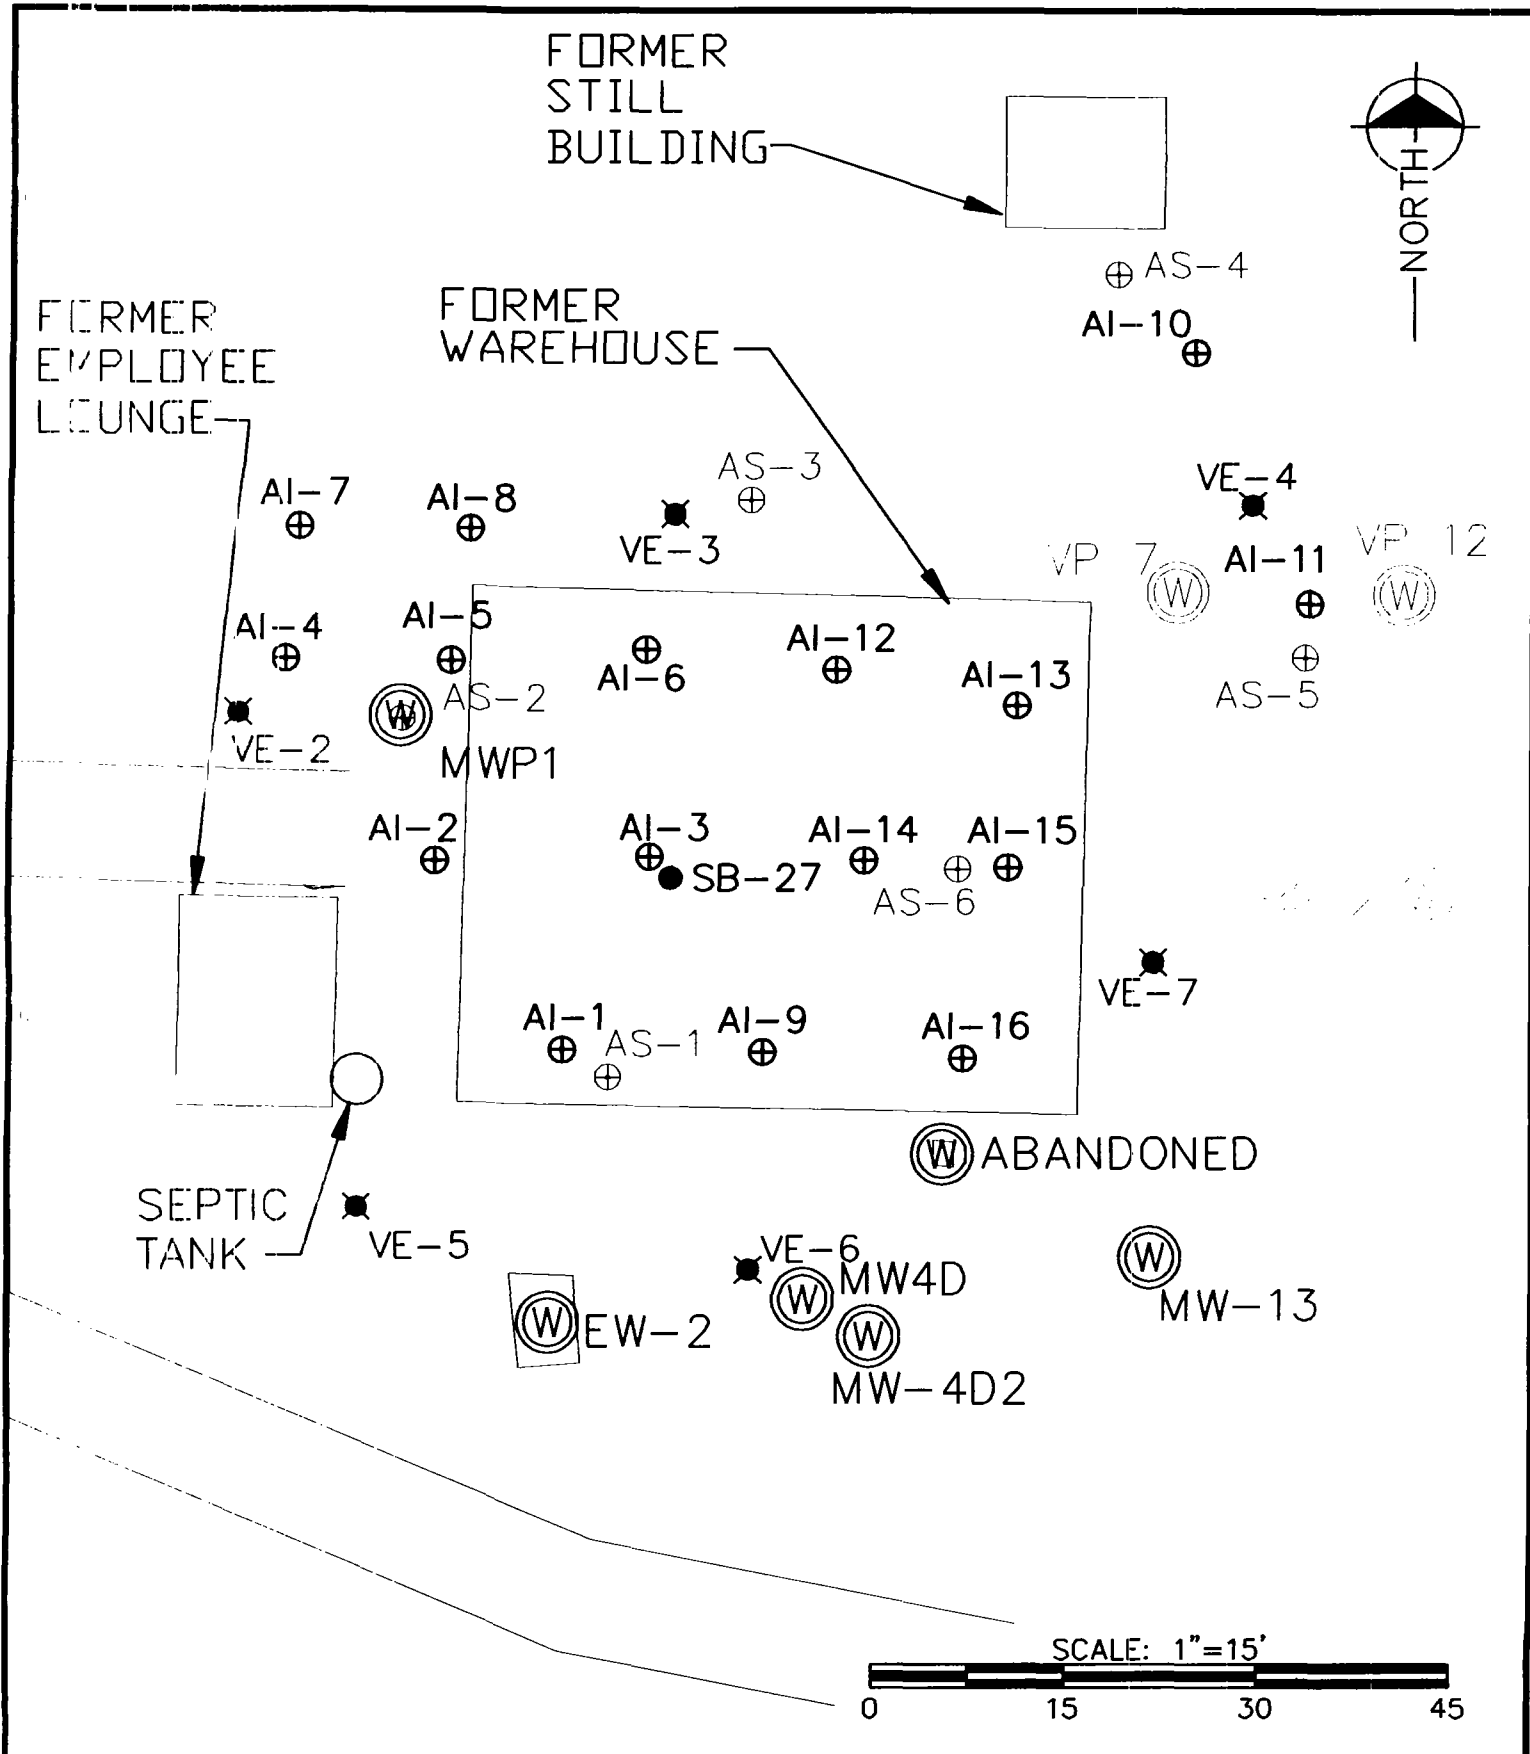
GRANVILLE SOLVENTS SITE
SEPTIC TANK LOCATION

Once the employee lounge was demolished, and the debris segregated, a concrete walkway between the former employee lounge and the warehouse was removed. Upon the removal of this concrete, a sanitary septic tank was discovered. The septic tank was located approximately 5 feet east of where the employee lounge once stood, and approximately 10 feet north of vapor extraction well VE-5. The septic tank was approximately 48 inches in diameter and approximately 5-1/2 feet deep. The septic tank contained approximately 4 feet of liquid and sludge. There were no obvious signs of piping runs leading away from the septic tank to a discharge point. The only piping discovered were two sections of clay tile, one 12 inch section to the west and one section to the east. Both sections of pipe were leading either into or out of the pre-cast holes on the east and west sides of the septic tank. Figure 2 depicts the location of the septic tank found during the demolition of the employee lounge and walkway.

A sample of the septic tank contents was collected on July 16, 2001 for waste disposal characteristics. The sample was analyzed for VOCs (8260), TCLP VOCs, TCLP SVOCs, TCLP RCRA metals, flashpoint, pH, and total VOCs. The laboratory analytical results of this sample included the detection of chlorinated solvents, benzene, xylenes, and six RCRA metals. Compounds detected at various concentrations are listed in Table 3.

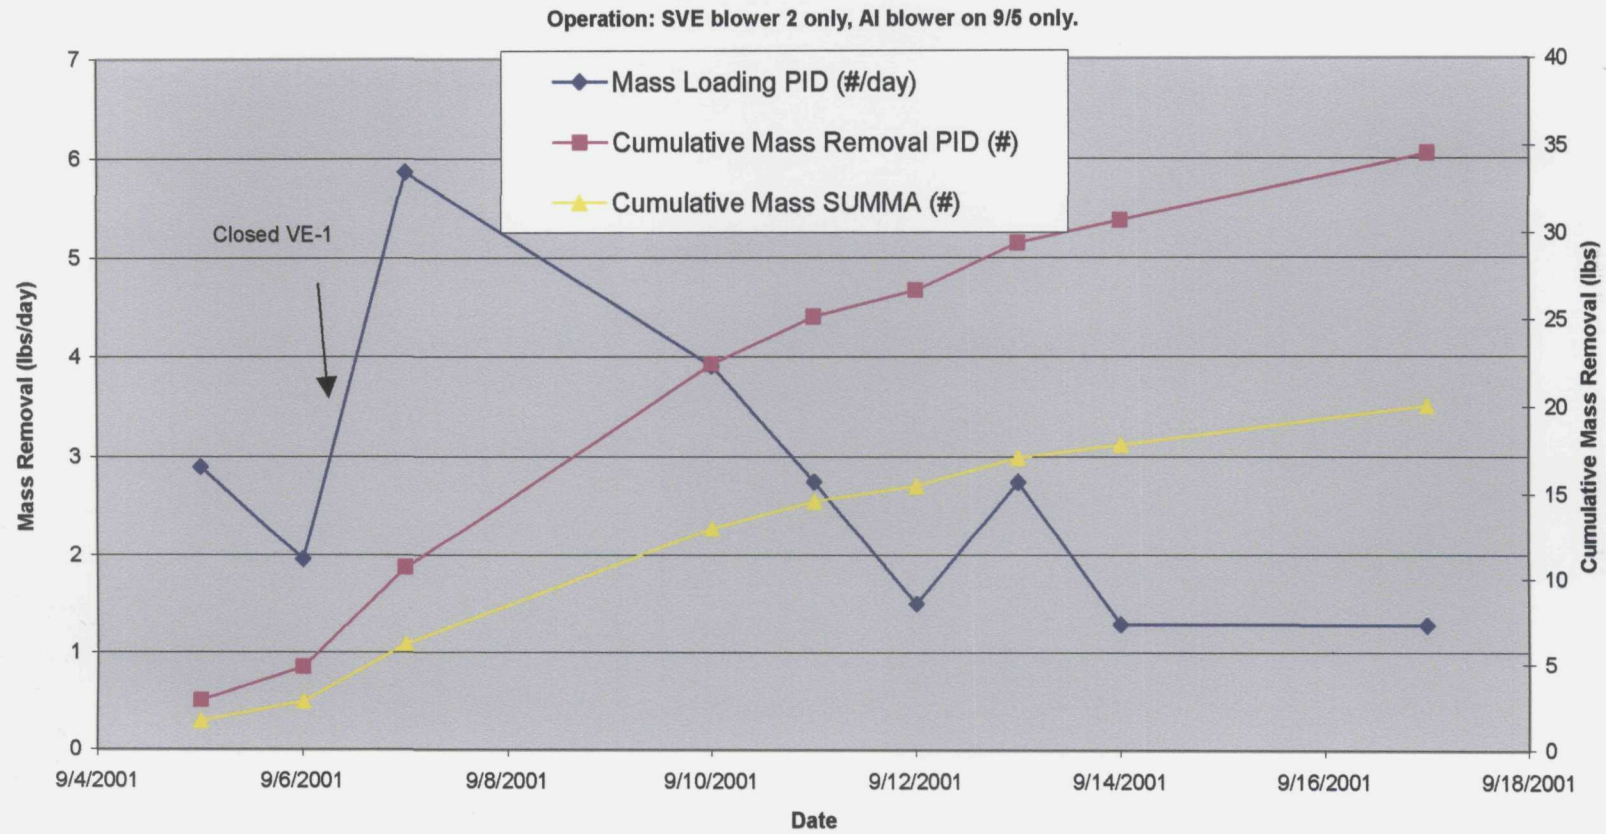
Figure 3. Granville Solvents SVE System
Estimated Mass Removal based on PID readings

The initial PID readings collected from the SVE effluent during startup were highest in well VE-6 (117 ppmV) and ranged from 25-55 ppmV in the other SVE wells. (The horizontal SVE well, VE-1 was not turned on during the startup period. This surface well causes vacuum in the vertical wells to drop off markedly.) After the initial PID readings, the effluent concentrations began to trend downward and have stabilized between 5 and 10 ppmV. Refer to Table 14 for operational data for the air injection and soil vapor extraction system.

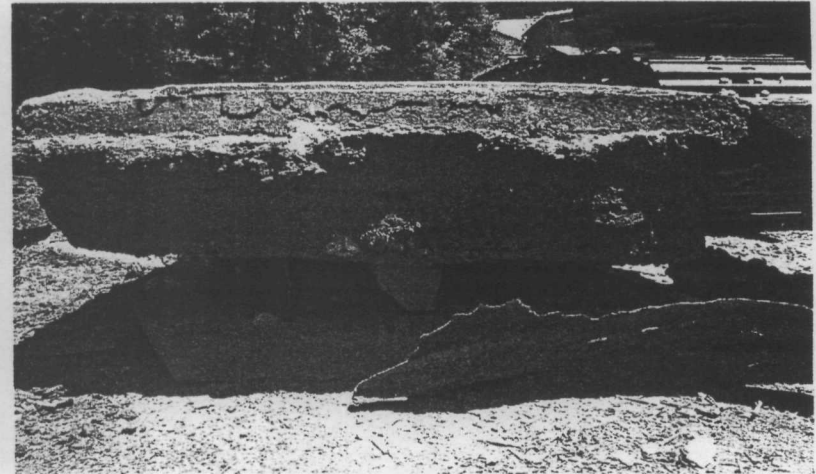
During the removal of the warehouse concrete floor two "catch basin" like structures were removed. One catch basin was located on the east side of the warehouse and one on the west side. The catch basin to the west, when removed, revealed a pea gravel base unlike the concrete floor, which had a compacted soil base. A sample of the pea gravel was collected and analyzed by Severn Trent Laboratories Inc., North Canton, Ohio, for VOCs (8260). Analytical data for those samples collected from the West Sump with detectable concentrations of contaminants are listed in Table 4.

Profile view of the western catch basin, note the clay tile which was leading down into the subsurface

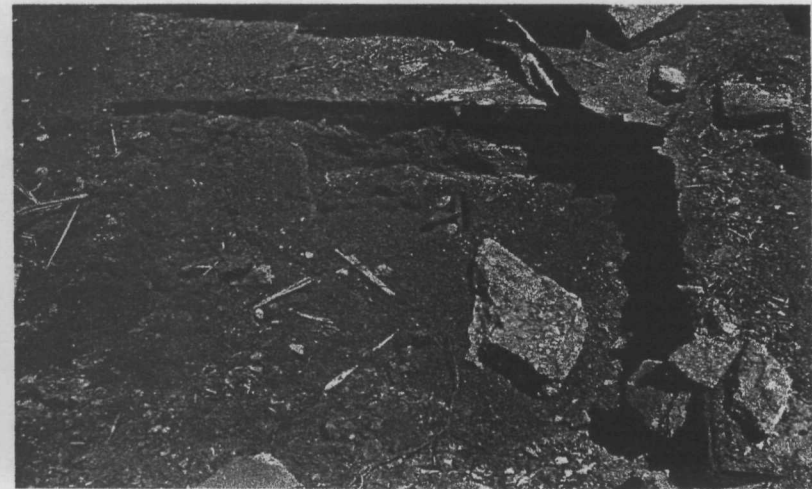
Photo of where the catch basin sat, note the clay tile leading into the pea gravel bedding

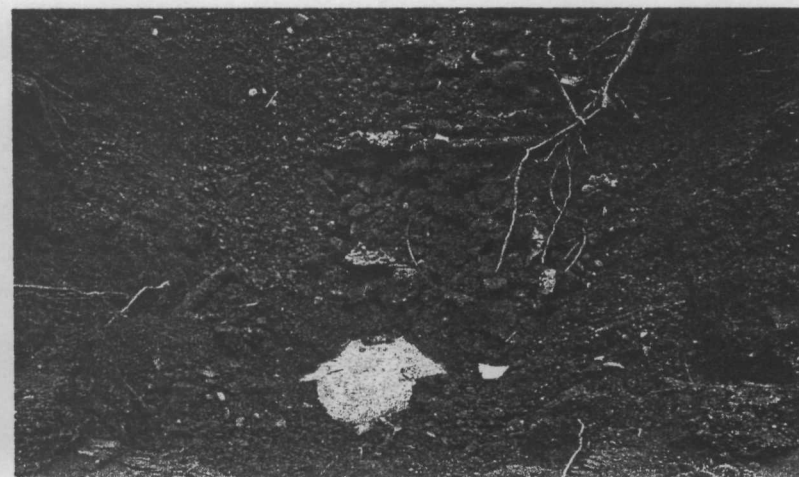
When the catch basin located in the eastern portion of the warehouse floor was removed, an 8-12 inch "hole" with an undetermined depth was observed. The "hole" contained free liquids and PID readings of 0.0 ppm were recorded at the level of the free liquid. The catch basin was removed and visually inspected. The catch basin showed no visible signs of piping running from the bottom of the structure, however, it was noted that the thickness of the catch basin base was not as thick as the other portion of the structure. A small line (~3/4 to 1 inch in diameter) ran approximately 3.5 feet below grade northeast to southwest next to the catch basin. The line was not connected through the catch basin, but was in two sections. Soil and liquid samples were collected from the east sump and were analyzed for VOCs (8260). Compounds detected at measurable levels are listed in Table 5.

View of the eastern catch basin hole, note the free liquids, and piping

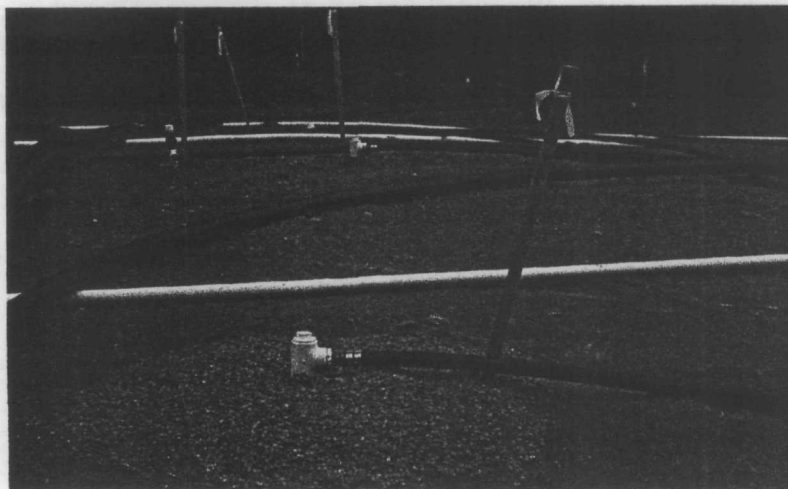
Two pressure tests were performed on August 21, 2001, one test on air injection wells and the other on air sparging wells. Both of the tests failed. Although the wellheads and fittings were installed as specified in the design plans, it was determined that the banded ends on the fittings, both at the wellheads and at the temporary treatment building were leaking and would not hold pressure.

During the installation of the treatment systems it was discovered that the plan-specified banded connections to the wellheads and manifold (within the treatment building) would not hold pressure. These banded connections were removed and replaced with HDPE fittings and hose barb connections.

Photo of an AI well with the failed band clamps

After evaluating various solutions, an HDPE transition fitting and threaded hose barb was selected for installation at each wellhead and at the treatment building to replace the design plan-specified banded fittings. This work entailed cutting out a section of HDPE piping at each wellhead and at the treatment building, and fusion welding the new fitting to the cut piping. Replumbing began on August 22, 2001 when the replacement parts and fusion welder were received from the supplier. After completing this work the lines were pressure tested between August 22, 2001 and August 27, 2001. Results of these tests are listed in Table 13.

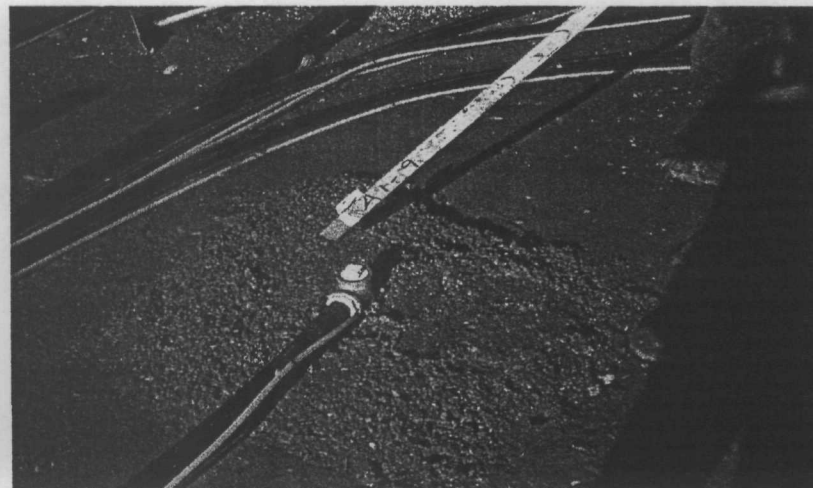
Photo of an AI well with the HDPE welded fittings and the hydration line in place
